POPPLETON HISTORIC STUDY

304-338 N. Carrollton Avenue

B-2416 304-338 N. Carrolton Street Block 0154 Lots 020-037 Baltimore City Baltimore West Quad.

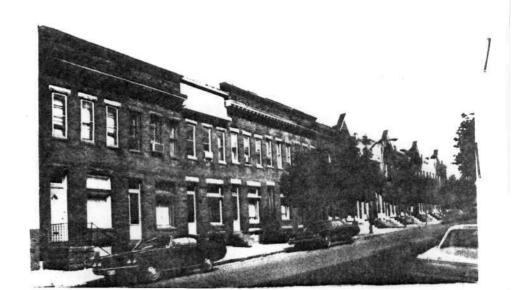
The southern portion of this terrace is somewhat younger than the upper, though not by much. Two distinct styles; two builders, likely. South portion Roman glazed brick, stone lintels and sills, steps. Heavy cornice treatment and transomed front windows. There are similar houses in Hampden and east Baltimore. The houses are well cared for.

The north portion has textured brick work in eccentric and varied patterns. Numbers 320-322 and 332-334 have been formstoned. All have marble steps and sills.

A quiet street, good and well kept houses on both sides. Carrollton is slated to get a foot-bridge across the expressway depression rather than a vehicular bridge. This should assure the quiet character of the street. Street trees are good but a few replacements are needed.
